EXECUTIVE SUMMARY

NASA and the Russian Space Agency (RSA) are involved in a cooperative venture in which the Shuttle will rendezvous and dock with the Mir Space Station during several missions from 1995 to 1998. This sequence of nine missions will serve as a precursor to the two nations' involvement in the International Space Station. These joint missions provide NASA scientists and engineers an opportunity to study the orbital, dynamic, and environmental conditions of long duration spacecraft, as well as develop evaluation and risk mitigation techniques which have direct application to the International Space Station.

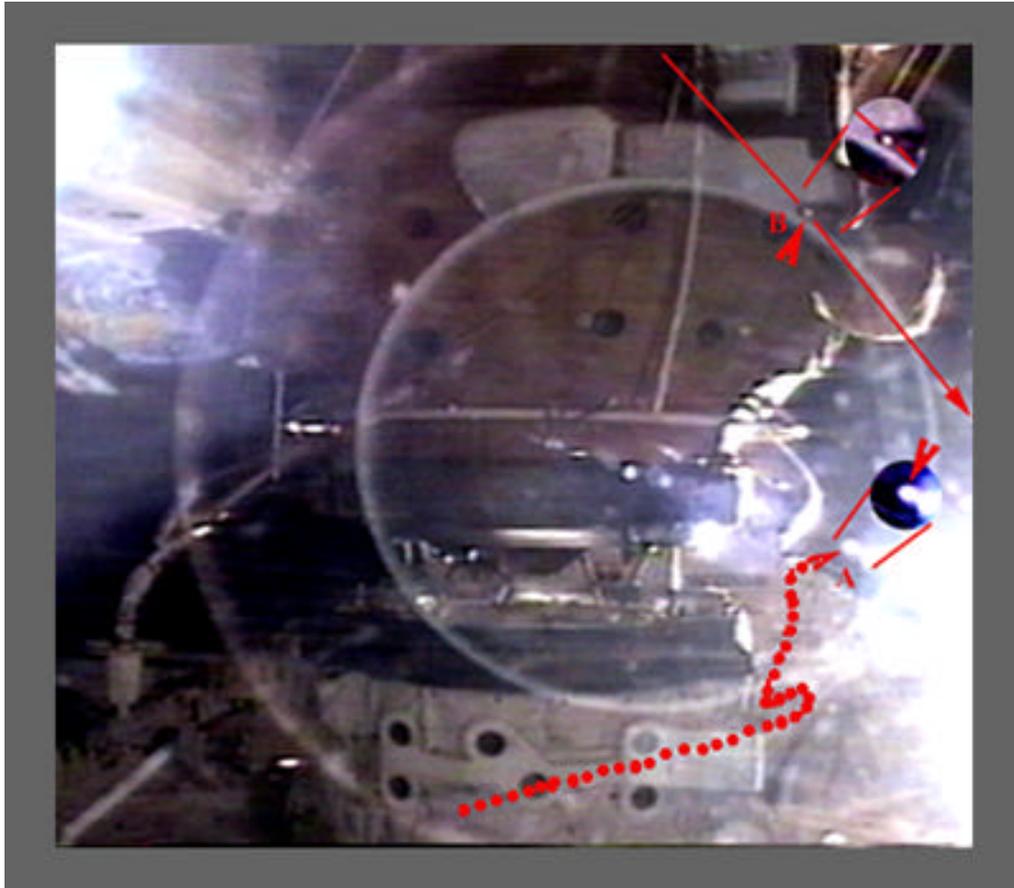
Figure 6.2 Debris Observed in Payload Bay Area during Soft Dock

observed at approximately 20 seconds after soft dock. In this figure, item A originates from the lower left of the camera field-of-view and traverses an irregular path until it makes contact with and adheres to the Camera A lens in the position shown. This piece of debris appears circular in the image and is adjacent to another unidentified feature on the lens. The unidentified feature is just to the lower right of the debris in Figure 6.2. The second piece of debris, item B, shows a single piece of debris which traverses in a direction such as to have possibly originated from Mir as indicated by the arrow. There is no observed impact of debris item B.

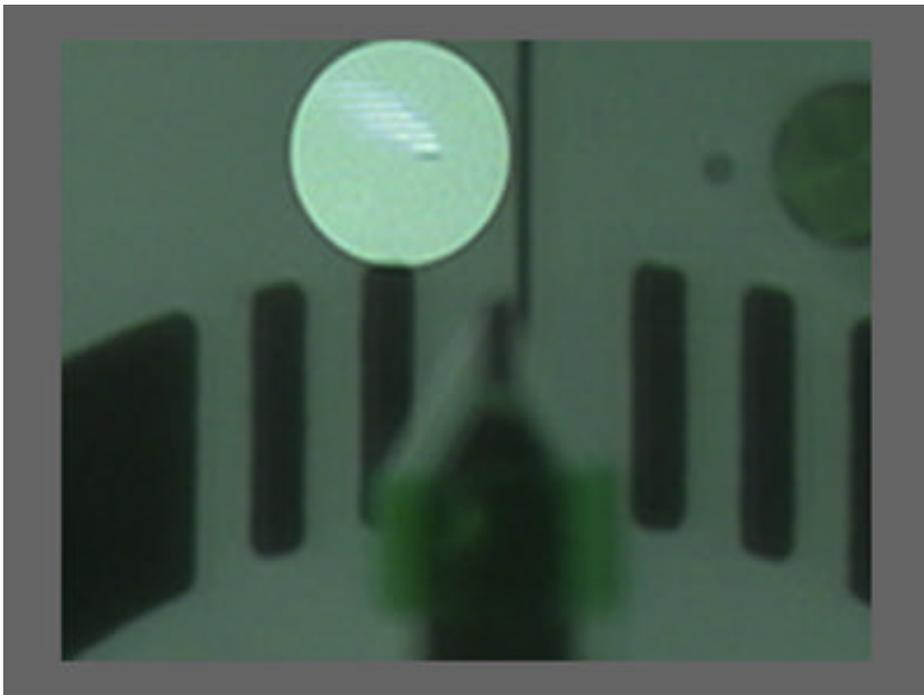
Figure 6.4 Apparent Debris Impact and Disintegration

The image in Figure 6.4 was taken by the centerline camera in the same time-frame (soft-dock) as the images in Figures 6.1, 6.2, and 6.3. Figure 6.4 shows an enhanced version of a part of one video frame which appears to indicate a debris impact and disintegration. Because the debris appears in only one frame, and there was no indicated effect on the target backplate, the apparent impact may have been on the lens surface rather than the target surface.

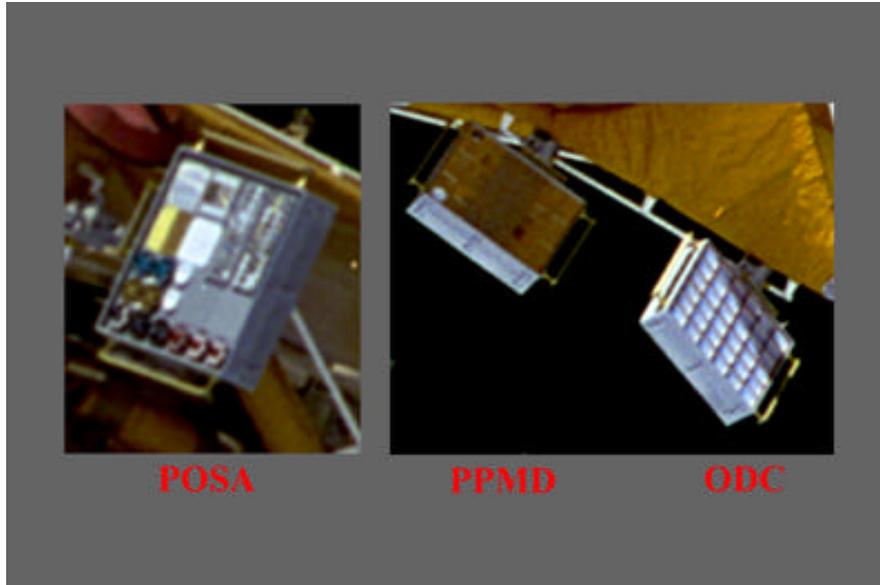
Figure 7.4 Still Photographs of POSA, PPMD, and ODC Back Panels

Figure 7.4 shows the back panels of POSA, PPMD, and ODC as extracted from Figure 7.1. The POSA view is face-on and no damage or discoloration is discerned. The ODC image, although oblique, is of good quality and no damage or discoloration is indicated. The imagery of PPMD also does not indicate damage or discoloration. However the polished metallic surfaces have substantial reflections of Mir which could mask potential discoloration.
